Layne Safety Alert

Subject: Periodic and Frequent Rigging Inspection

Date: July 7, 2009

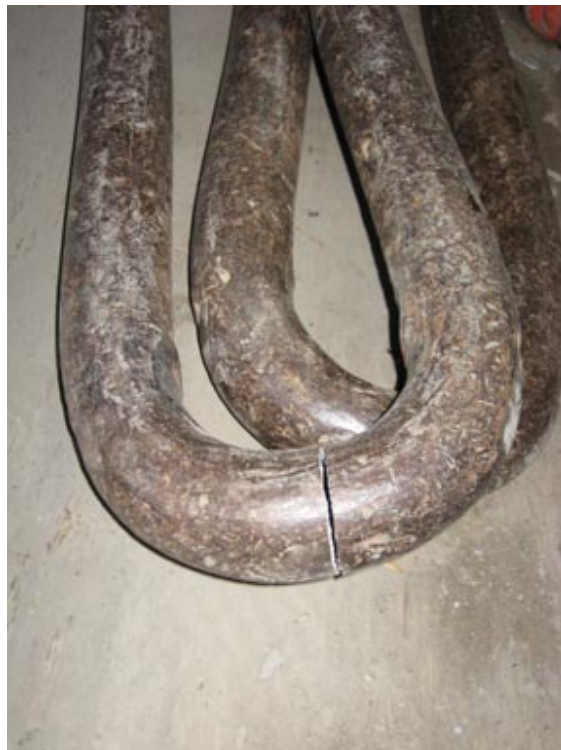
Incident: A Layne Christensen Crew was setting 18" well screen with a calculated string weight of 110,000 pounds. A crew member was observing the lift of a 40' long 18" o.d. section of pipe when he observed a split in the lifting link. The lift was immediately stopped and after a HIRA evaluation the stick was lowered to the ground. A complete split was found in the 2 7/8 inch diameter in the lifting link. Upon closer inspection it was determined that the link did not have a manufacturers ID or a working load limit incorporated on the link. The current regulation requires this information to be forged or die cast into the body of the link. The root cause was determined to be that the link had been used past its fatigue cycle and had not received none destructive testing (magnafluxed) during its service life.

Recommendations: Review the periodic and frequent inspection criteria for rigging and hardware. Place all rigging out-of-service that does not meet current standards. Implement non-destructive testing cycles on critical lifting devices.
